## Site Photographs

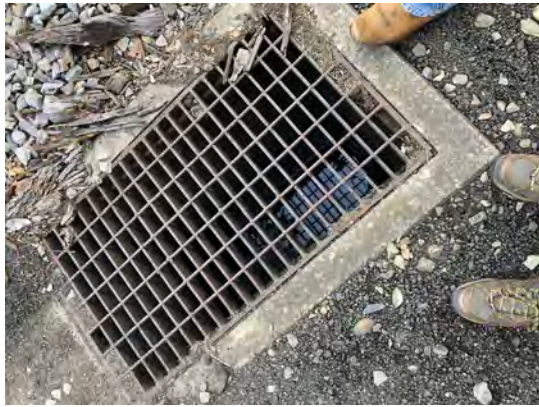
Photograph 15: Sewer grate for public water supply along railroad.

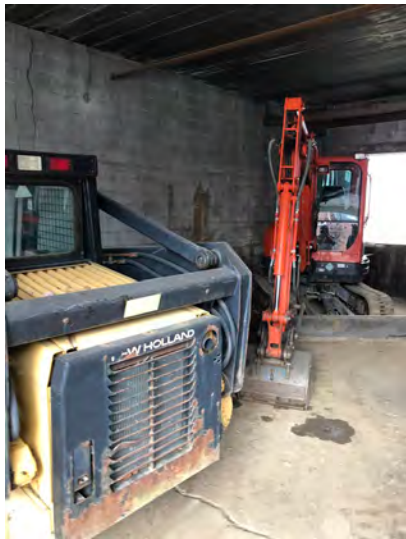
Photograph 17: Equipment in former dry-cleaning building.

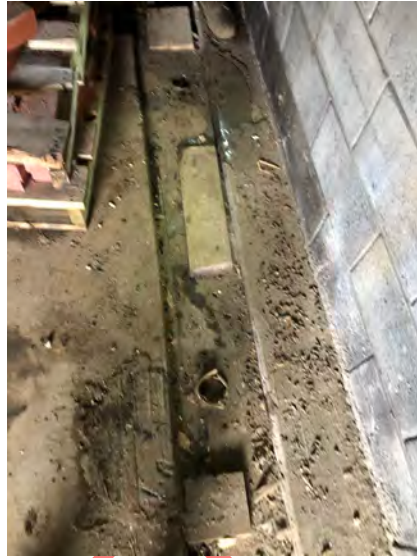
Photograph 20: Drainage features in former dry-cleaning building.

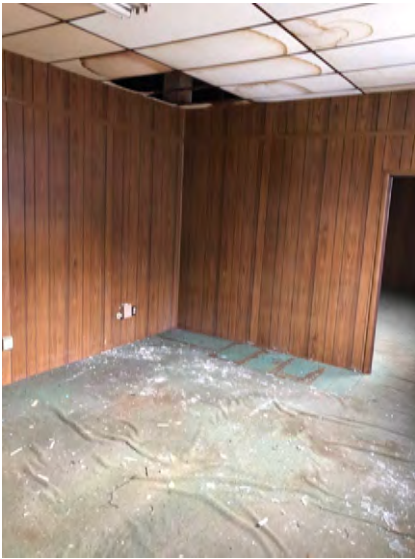
Photograph 21: Office space.

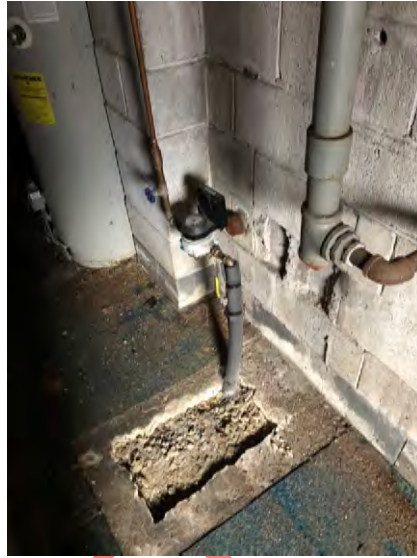
Photograph 24: Water and gas hookup in former dry-cleaning building.

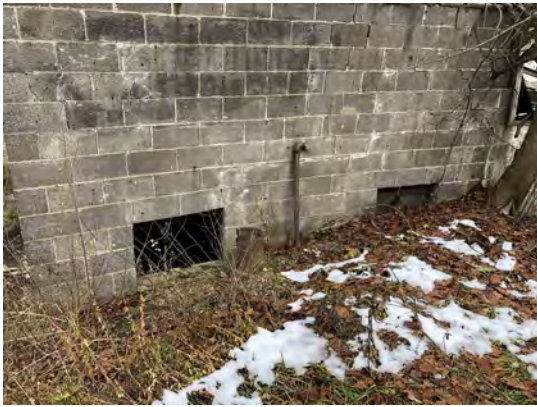
Photograph 37: Vent pipe and fill pipe for UST outside boiler room building.

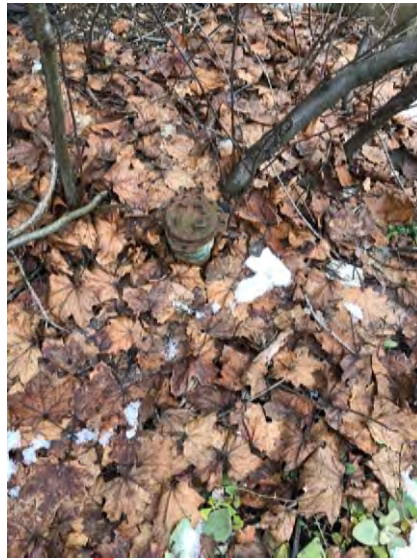
Photograph 38: Fill pipe for UST outside boiler room building.

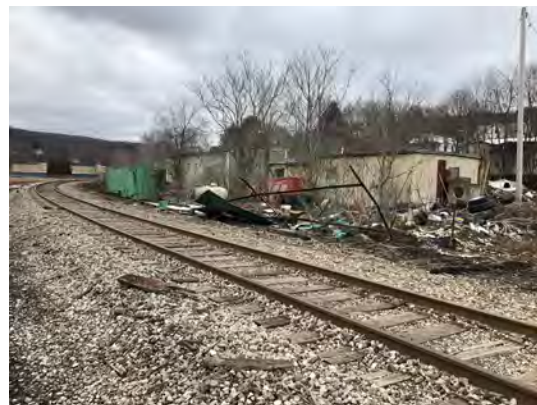
Photograph 45: Stained soils, looking west towards Webco site.

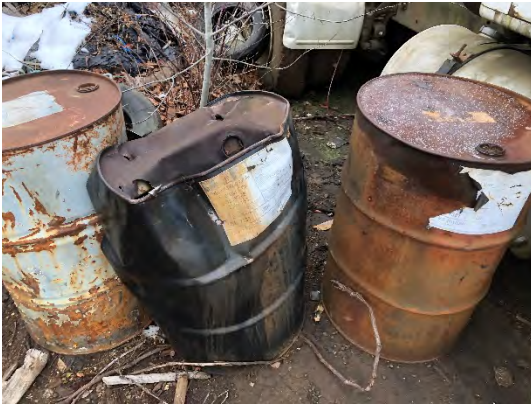
Photograph 47: Three 55-gallon drums with stained soils.

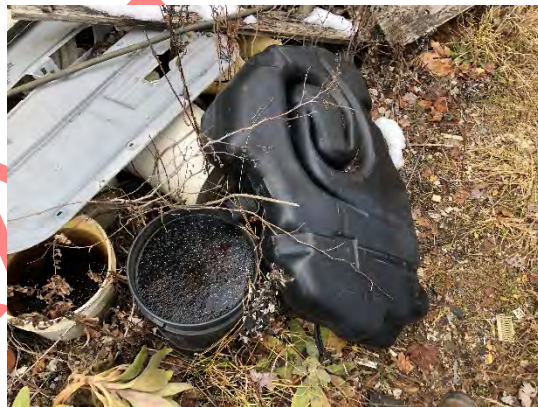
Photograph 56: Gas tank in scrap pile.

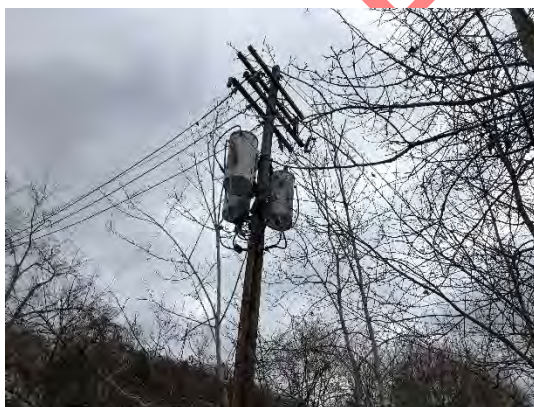
Photograph 63: Electrical transformers located on Dahlstrom property.

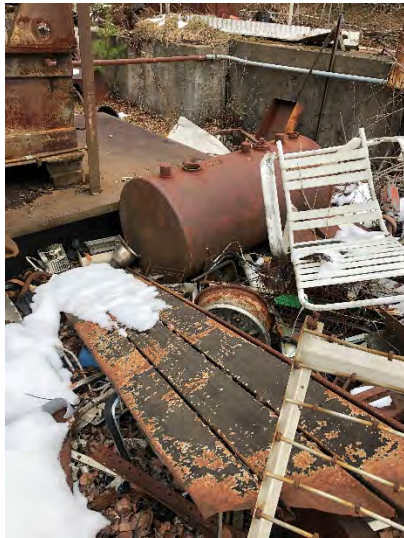
Photograph 65: Scrap pile and old UST.

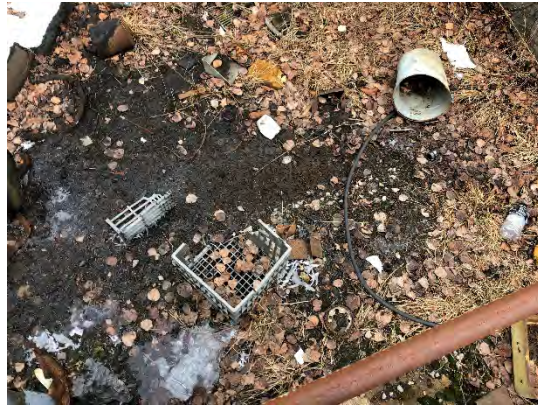
Photograph 66: Stained soils around scrap yard equipment.

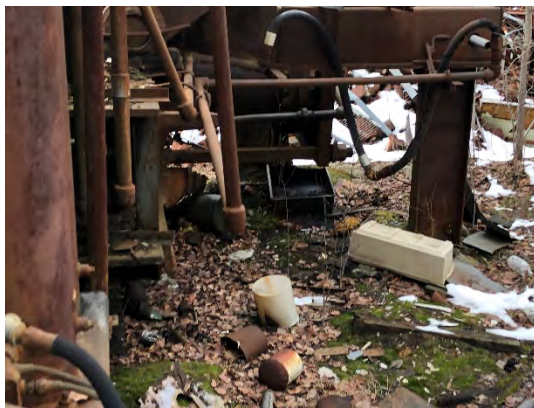
Photograph 67: Buckets catching fluids under scrap yard equipment.

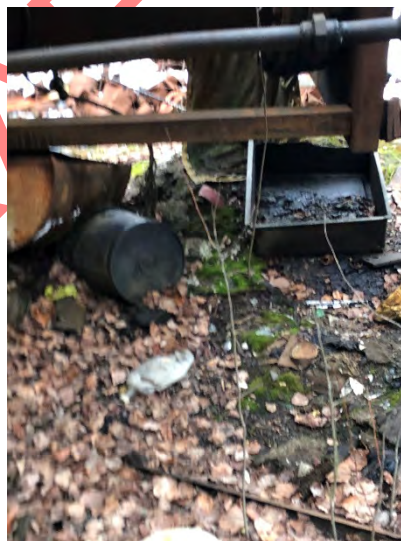
Photograph 68: Buckets catching fluid under scrap yard equipment and stained soils.

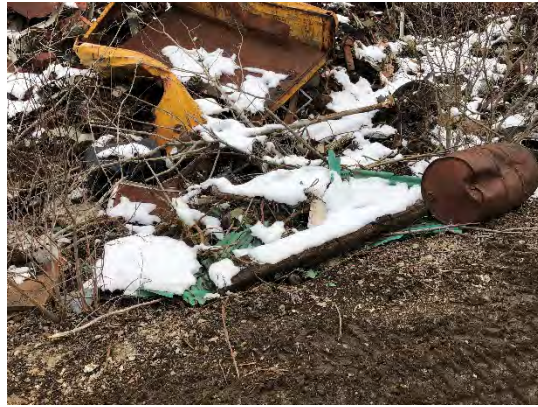
Photograph 70: 55-gallon drum in scrap pile.

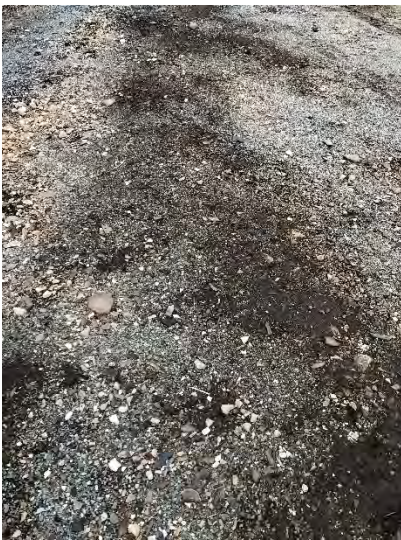
Photograph 75: Stained soils on Kraft and Dahlstrom property.

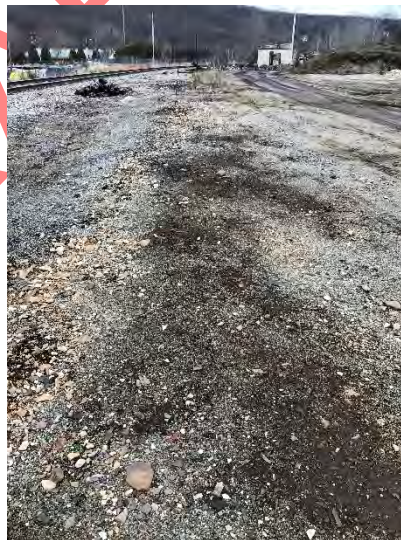
Photograph 76: Stained soils on Kraft and Dahlstrom property.

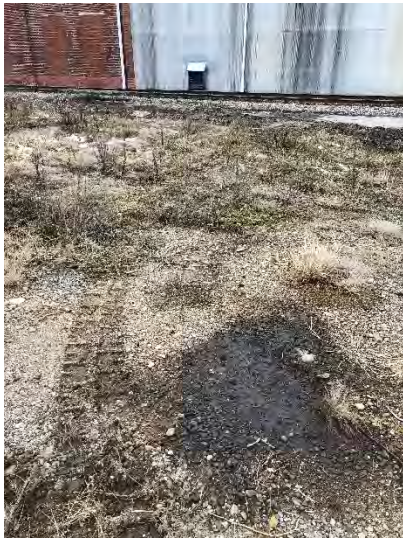
Photograph 77: Stained soils on Kraft property.

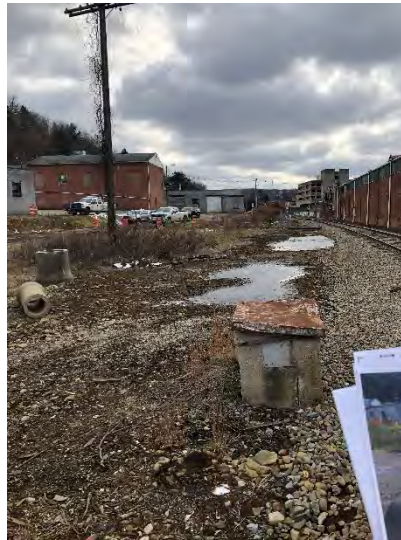
Photograph 78: Stained soils on Kraft property.

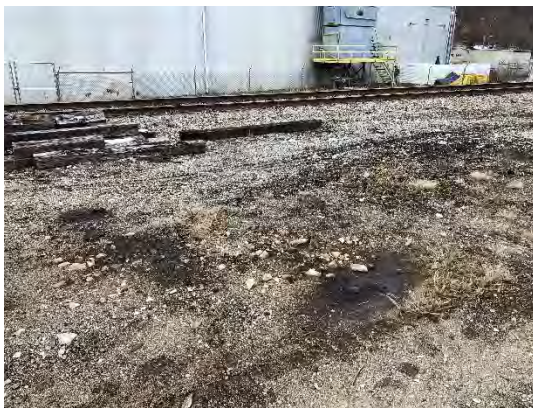
Photograph 79: Stained soils on Kraft property.

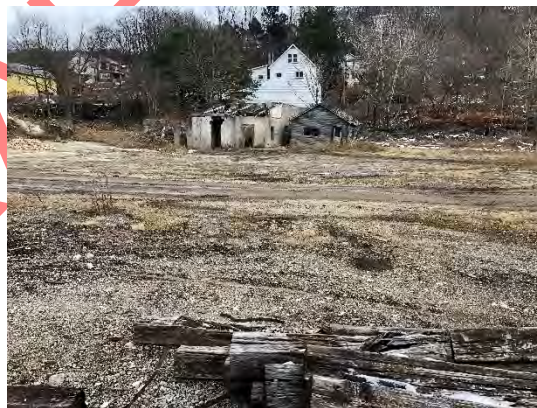
Photograph 80: Stained soils on Kraft property looking east towards office and boiler room building.

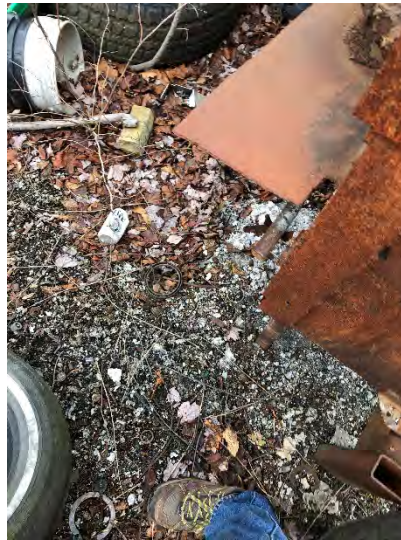
Photograph 94: Burnt waste on ground from homemade smelter.

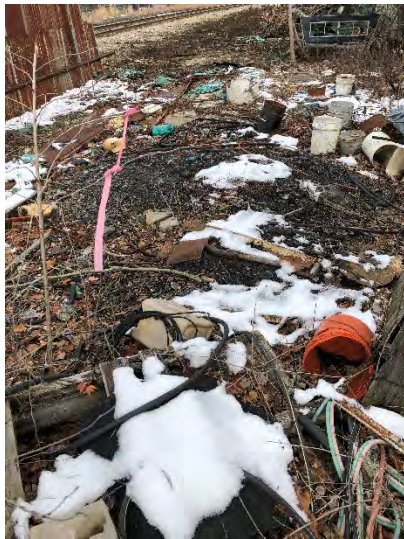
Photograph 95: Burnt waste on ground from homemade smelter.

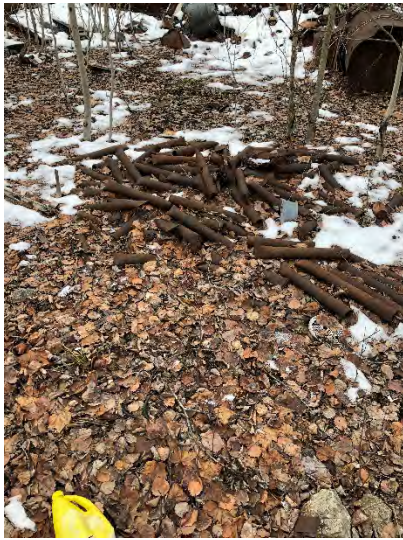
Photograph 97: TENORM pipe sections.

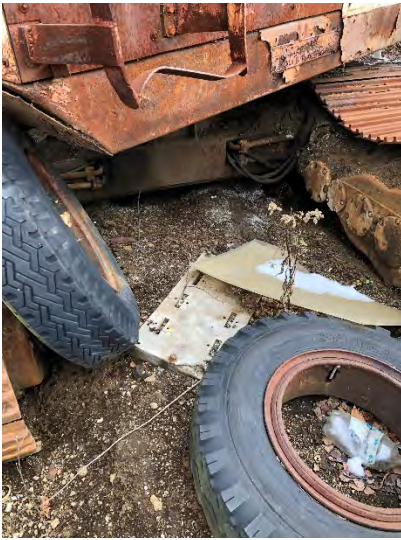
Photograph 101: Staining around scrap yard equipment.

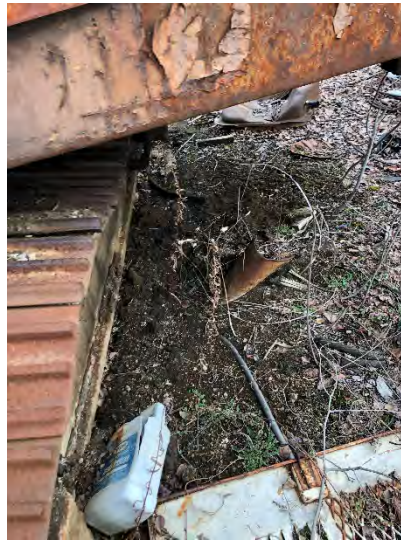
Photograph 102: Staining around scrap yard equipment.

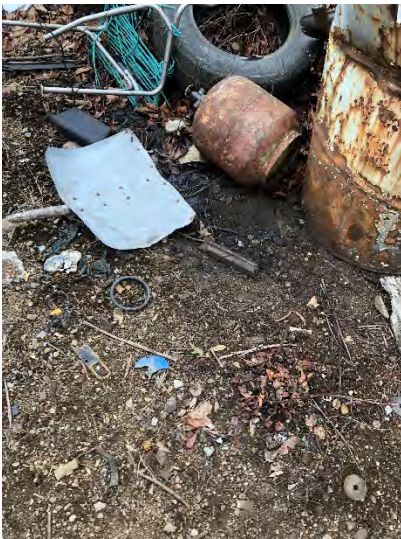
Photograph 103: Staining on Dahlstrom property.

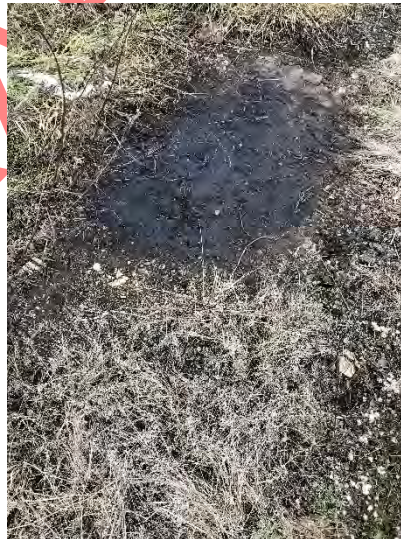
Photograph 104: Staining on Kraft property.

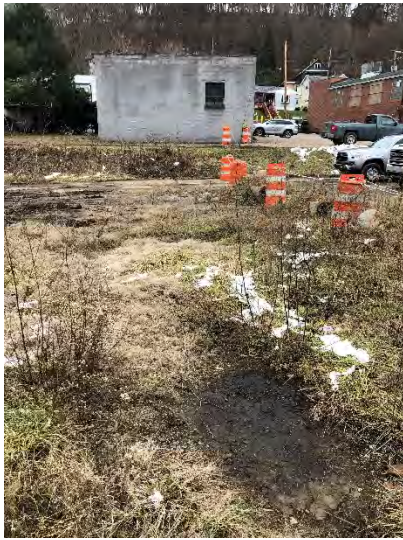
Photograph 105: Staining on Kraft property.

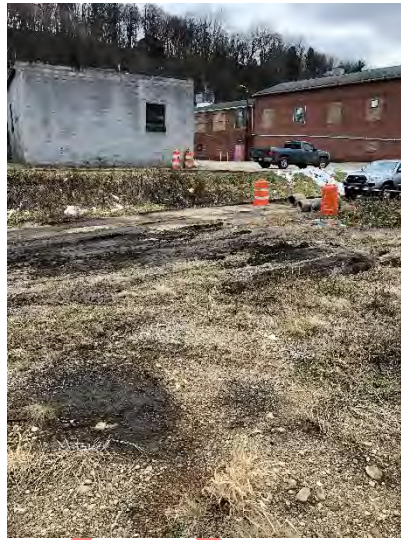
Photograph 106: Staining on Kraft property.
