## Site Photographs

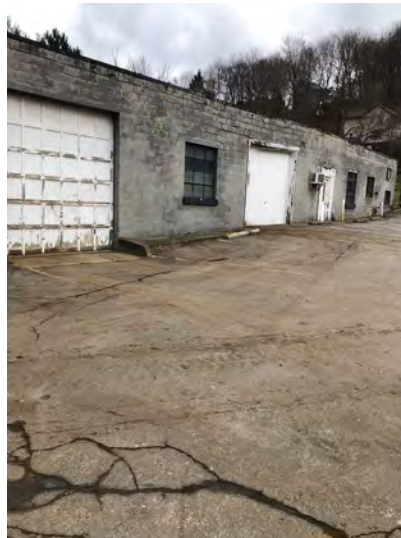
Photograph 16: Former dry-cleaning building.

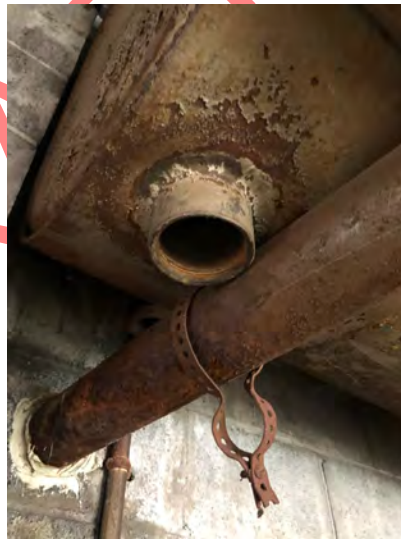
Photograph 18: Empty suspended AST in former dry-cleaning building.

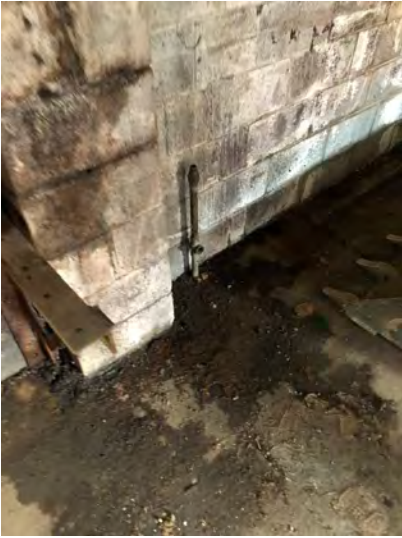
Photograph 19: Pipe below suspended AST.

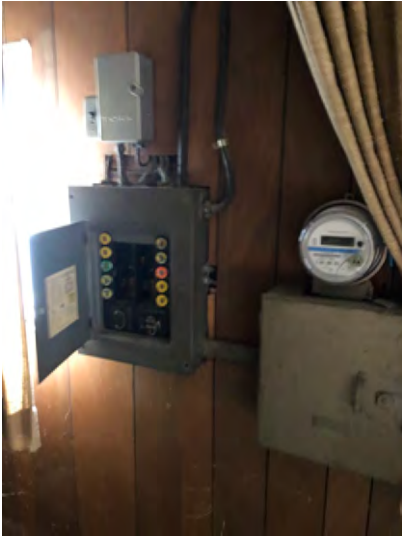
Photograph 23: Electrical in former dry-cleaning building.

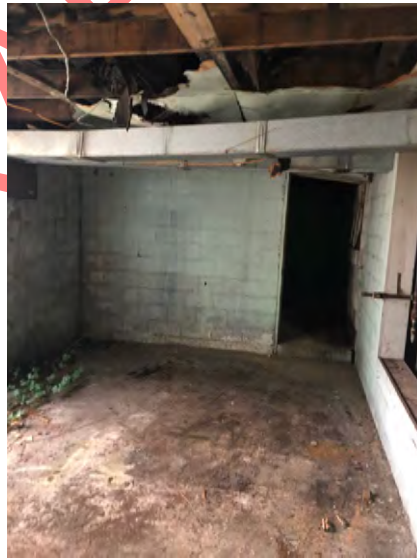
Photograph 26: Rear room in former dry-cleaning building.

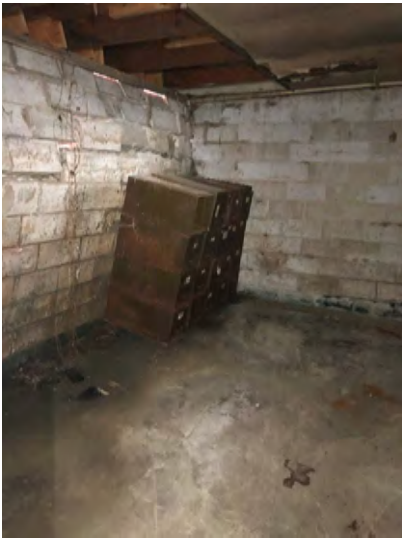
Photograph 27: Rear room in former dry-cleaning building.

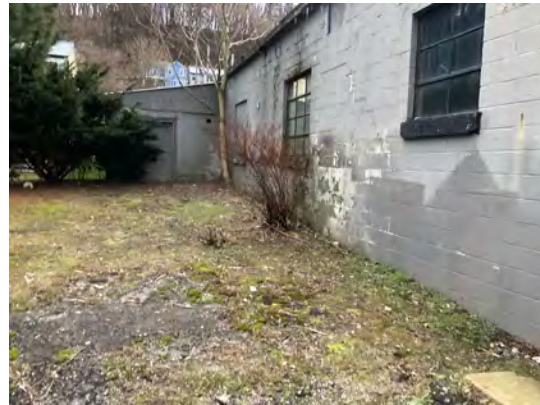
Photograph 28: Rear of former dry-cleaning building.

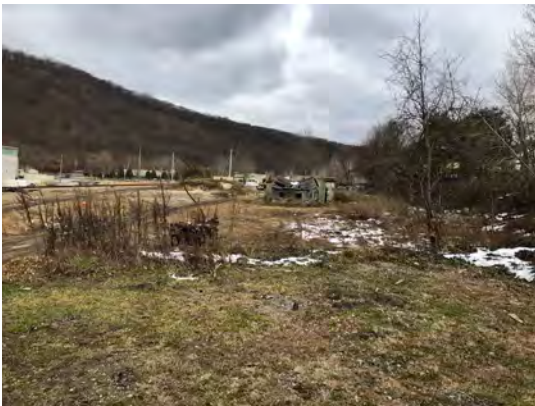
Photograph 29: View looking north from former dry-cleaning building.

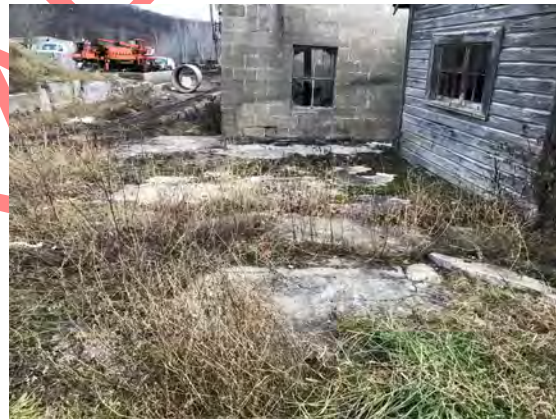
Photograph 30: Office and boiler room building.

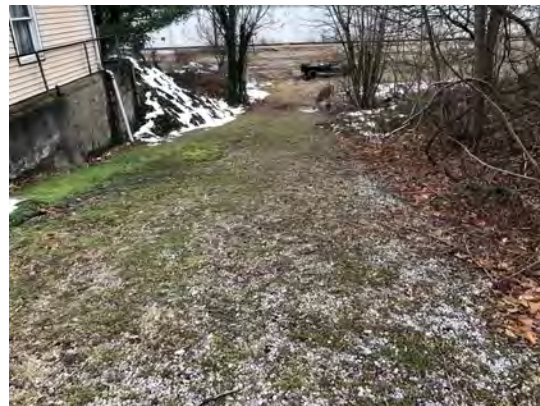
Photograph 32: Entryway easement to Kraft property.

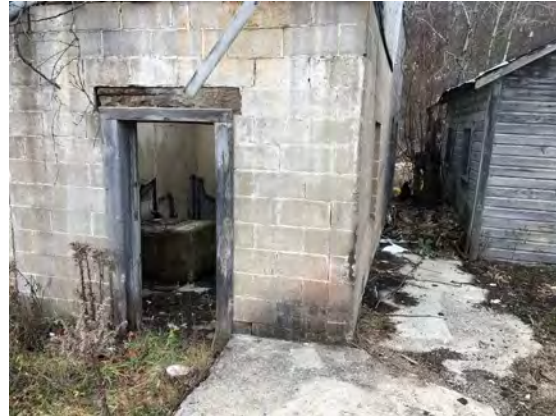
Photograph 34: Boiler room building (left), office (right)

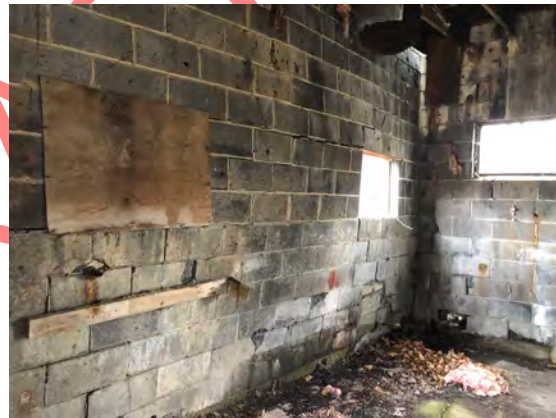
Photograph 36: Inside of boiler room building.

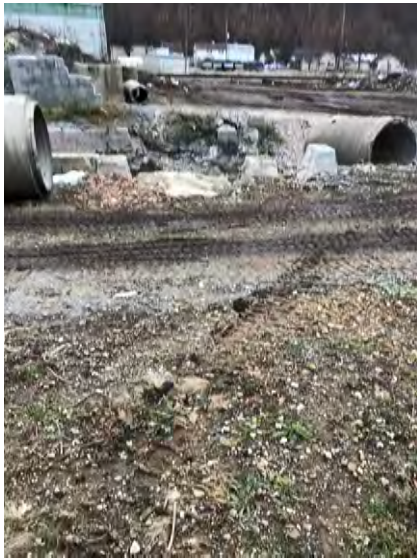
Photograph 39: Trench and old materials for concrete manufacturing.

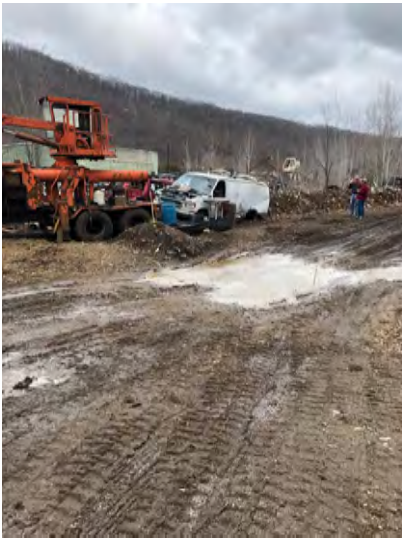
Photograph 41: Equipment on Dahlstrom property.

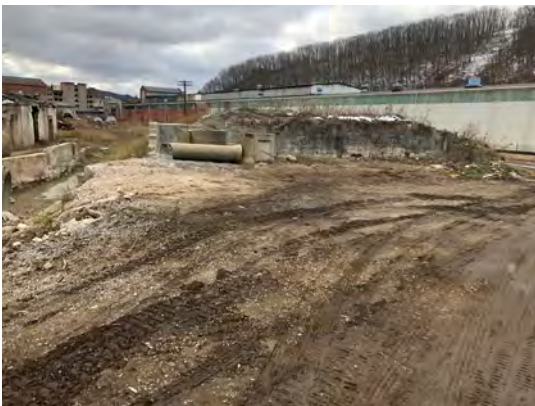
Photograph 43: Old concrete manufacturing storage area.

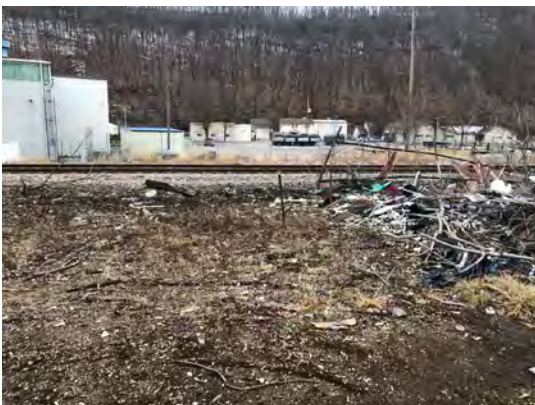
Photograph 45: Stained soils, looking west towards Webco site.

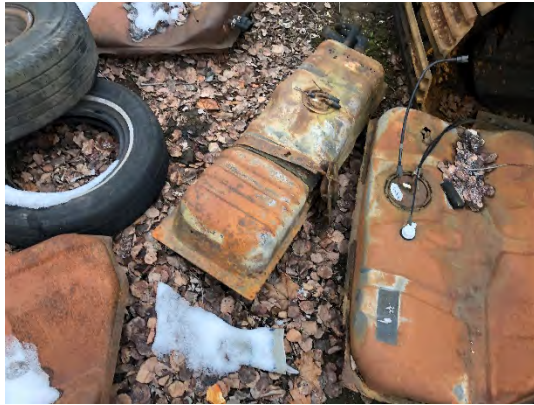
Photograph 59: Fuel tanks, tires, scrap.

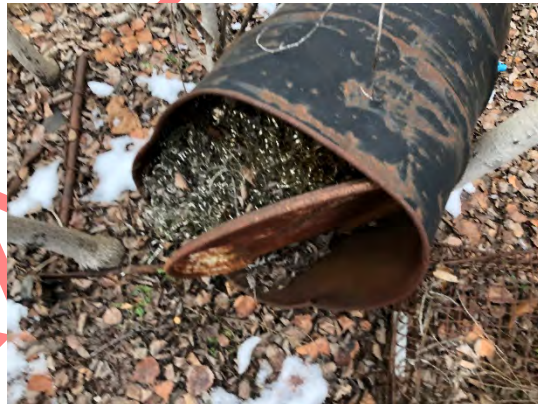
Photograph 62: Metal shavings in barrel on Dahlstrom property.

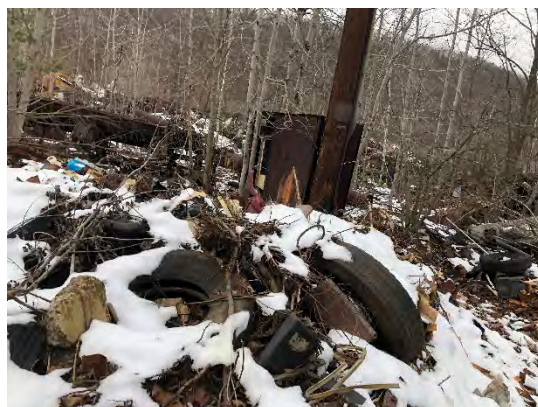
Photograph 64: Scrap pile below electrical transformers..

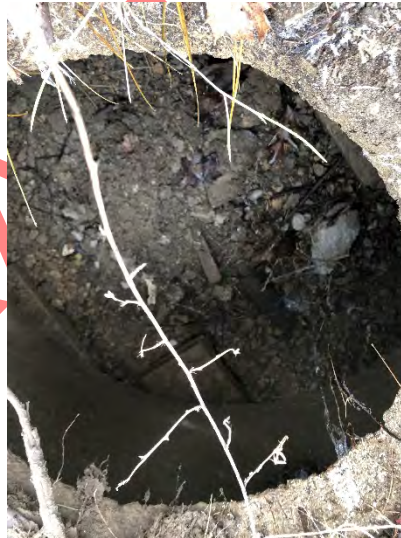
Photograph 72: Valve for public water supply.

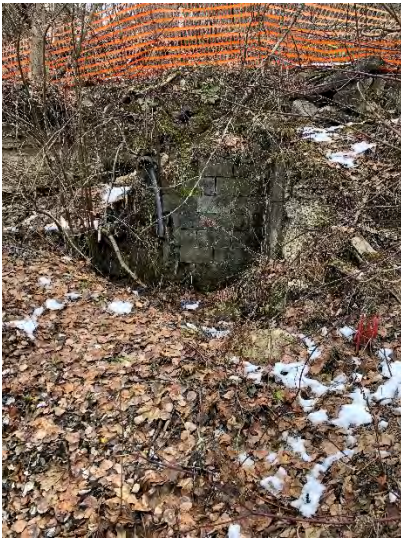
Photograph 73: Unknown pipe exiting bank on east side of Kraft property.

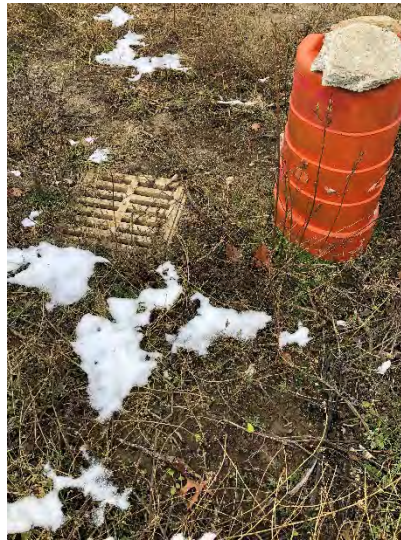
Photograph 74: Drain in center of subject site.

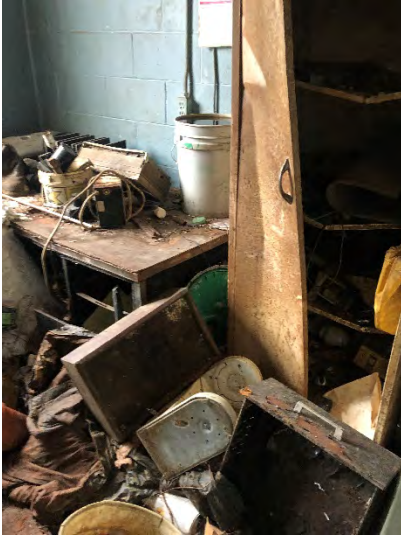
Photograph 81: Debris inside Dahlstrom office.

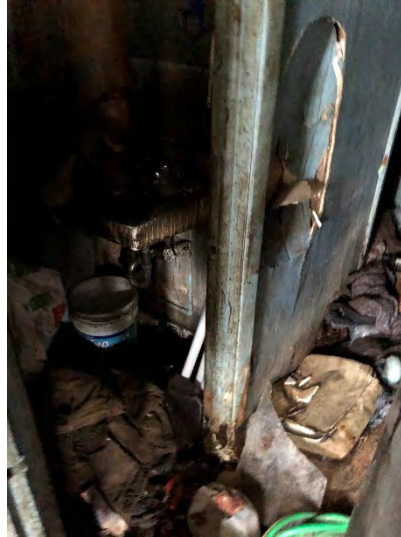
Photograph 82: Debris inside Dahlstrom office.

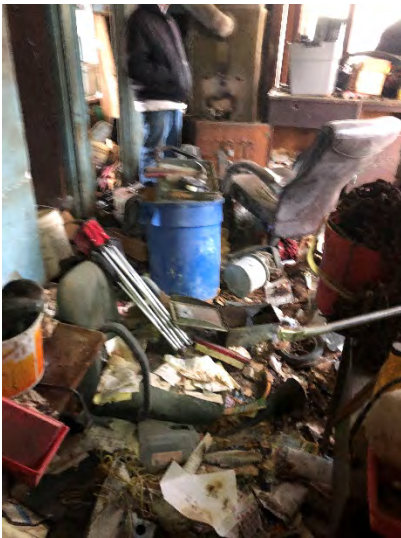
Photograph 83: Debris inside Dahlstrom office.

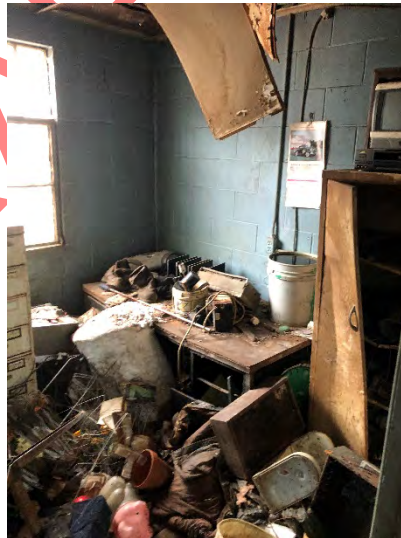
Photograph 84: Debris inside Dahlstrom office.

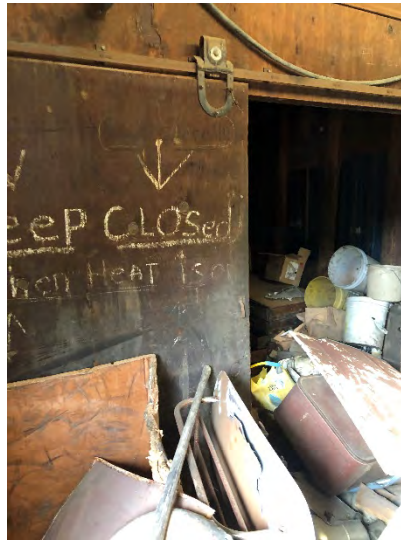
Photograph 86: Debris and scrap in Dahlstrom garage.

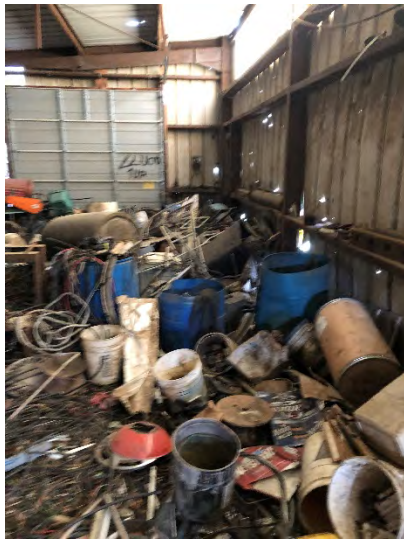
Photograph 87: Debris and scrap in Dahlstrom garage.

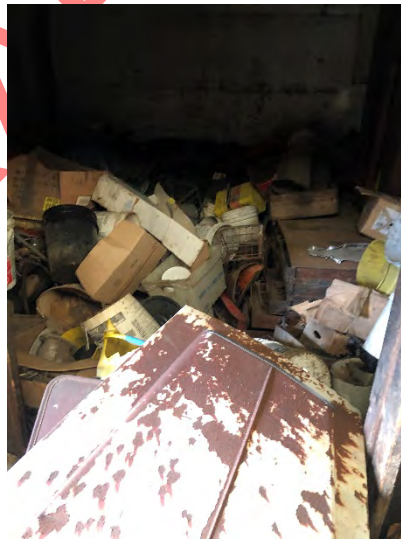
Photograph 88: Debris and scrap in Dahlstrom garage.

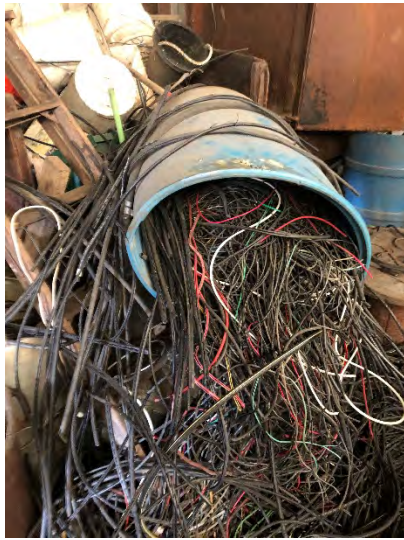
Photograph 89: Debris and scrap in Dahlstrom garage.

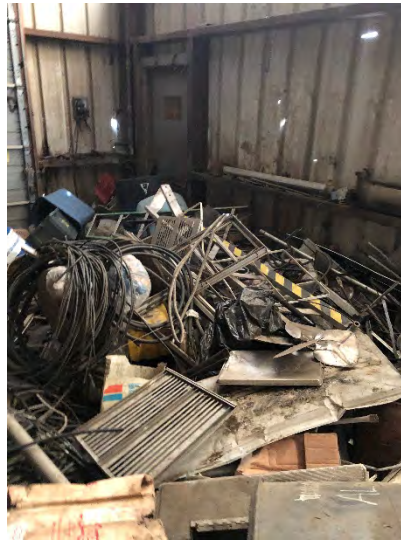
Photograph 90: Debris and scrap in Dahlstrom garage.

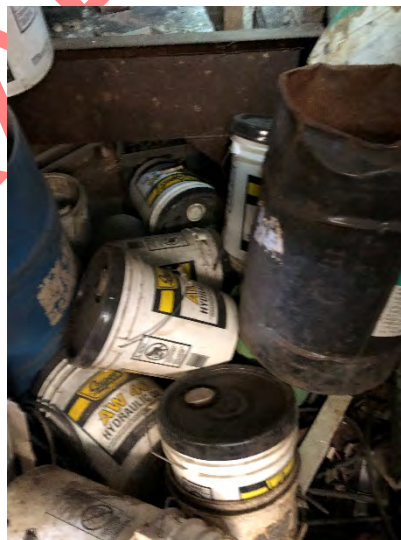
Photograph 92: Empty buckets and scrap in Dahlstrom garage.

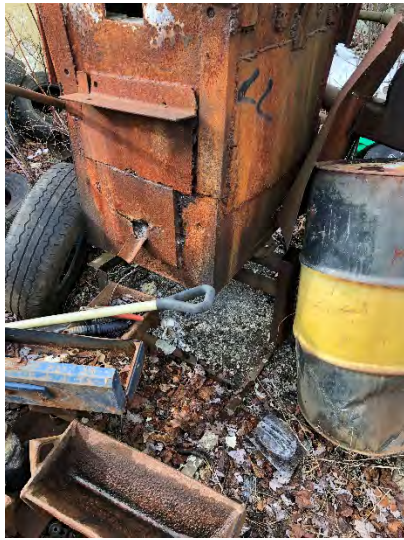
Photograph 93: Homemade smelter and burnt waste.

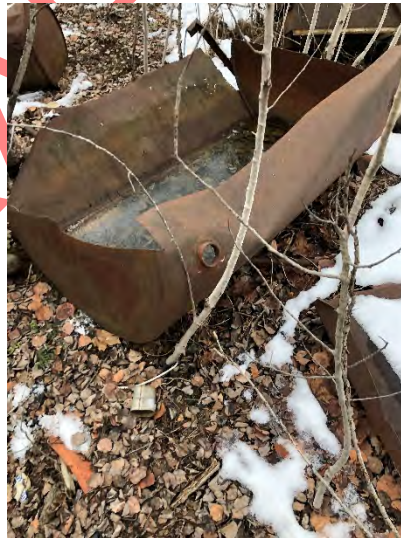
Photograph 100: Split old UST.
