Invitation For Bids (IFB) – Coal Oil Johnny House Exterior Painting and Repairs

Issued by the Oil Region Alliance on October 27, 2021.

BIDS For Exterior Painting and Repairs At The Coal Oil Johnny House

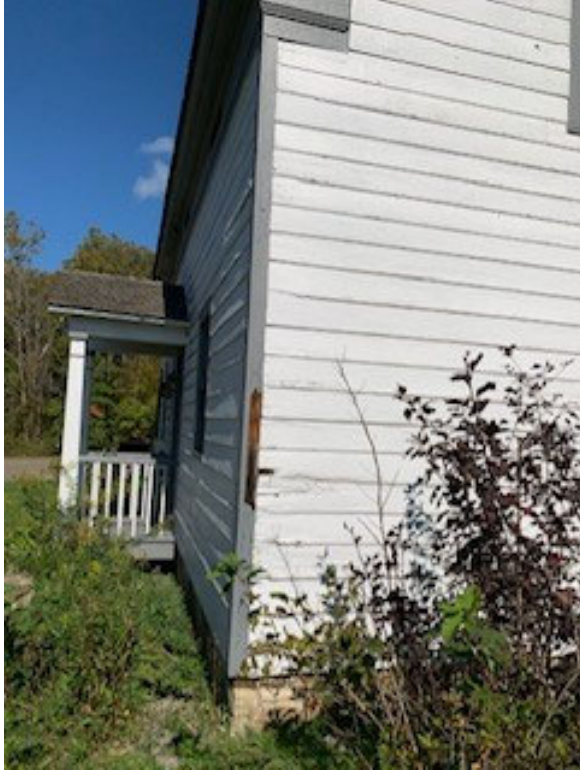
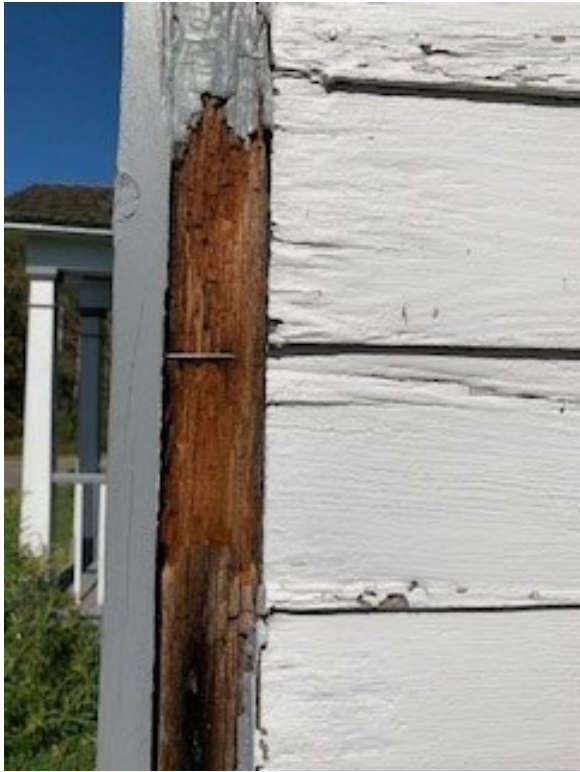
Rotting corner board on left side facing wall with detail photo. Encapsulate and repair with Abatron WoodEpoxy Wood Repair Kit, sand, and repaint. Replace if necessary.
