## Site Photographs

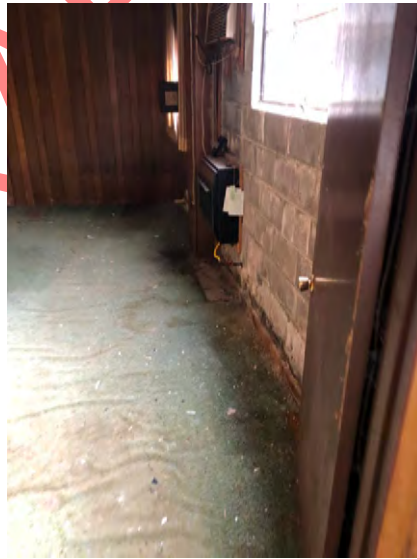
Photograph 22: Office space

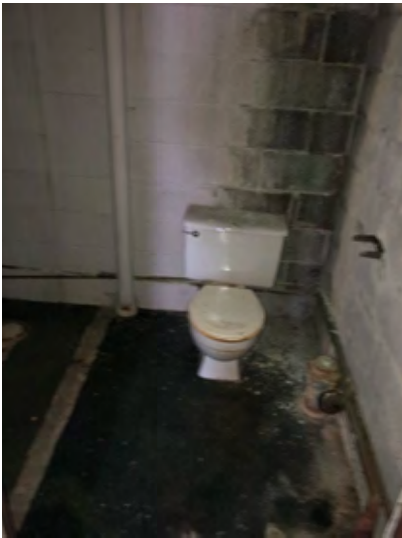
Photograph 25: Bathroom.

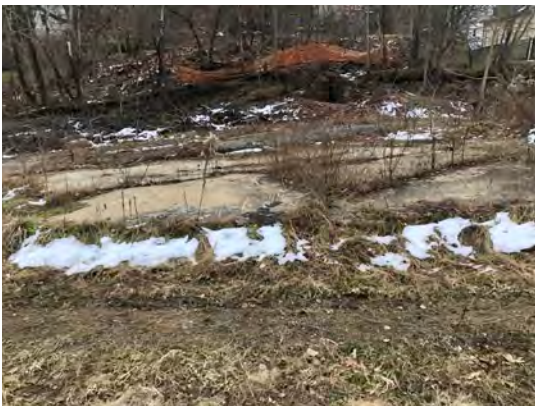
Photograph 31: Foundation remnants of former cement block garage.

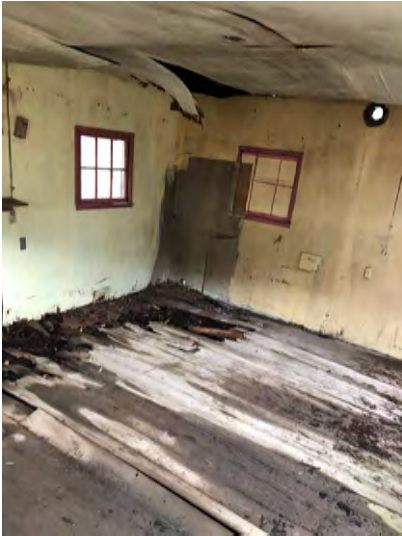
Photograph 33: Office.

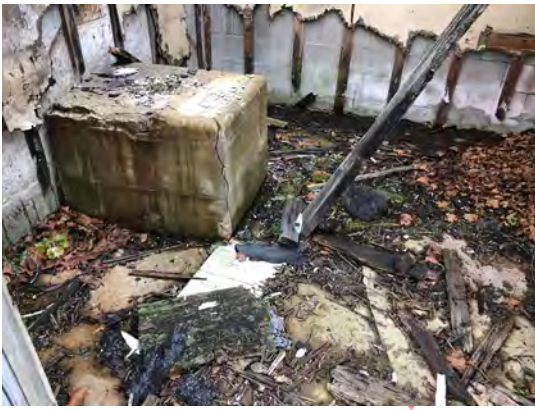
Photograph 35: Inside of office building.

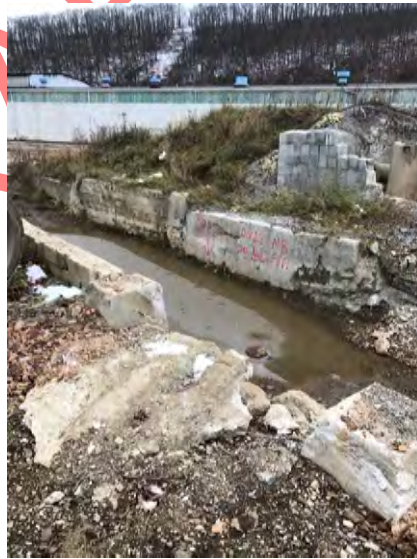
Photograph 40: Concrete trench.

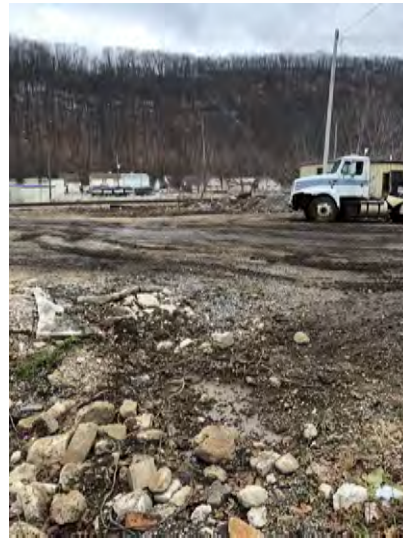
Photograph 42: Equipment on Dahlstrom property looking west towards Webco.

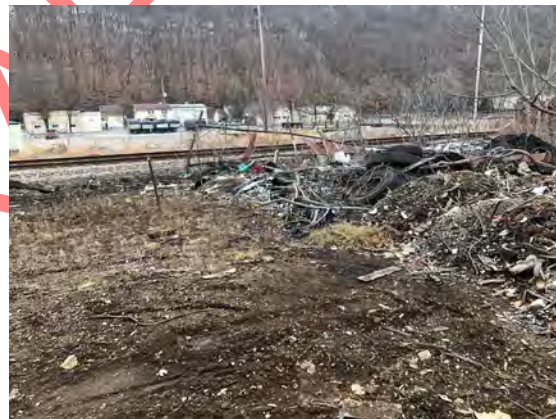
Photograph 44: Scrap pile looking west towards Webco site.

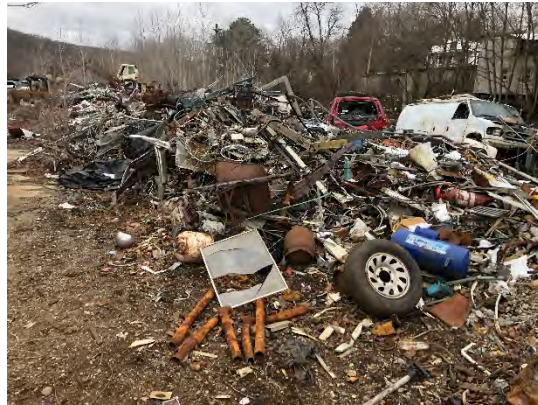
Photograph 48: Scrap pile.

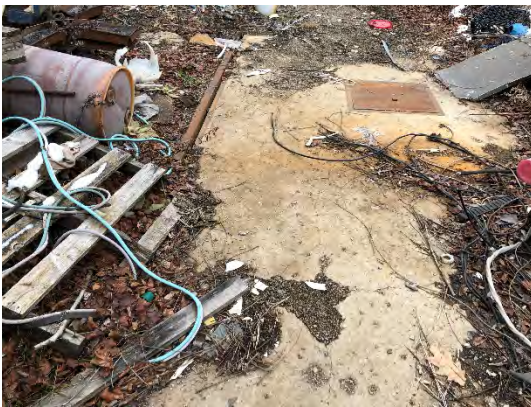
Photograph 49: Scrap, drum, and scale.

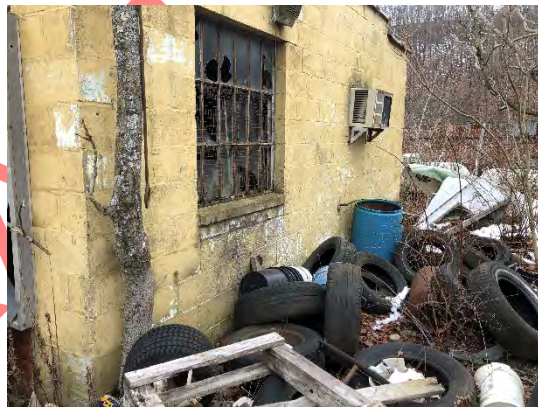
Photograph 50: Dahlstrom office building and scrap.

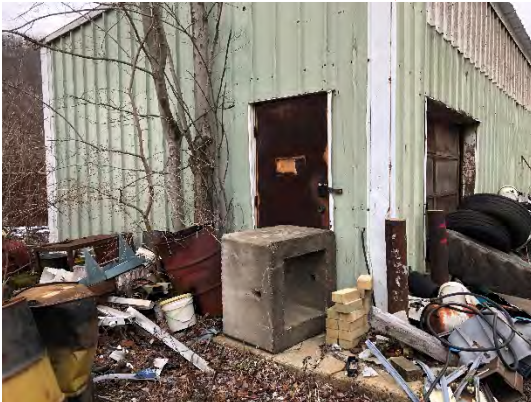
Photograph 51: Dahlstrom garage and scrap.

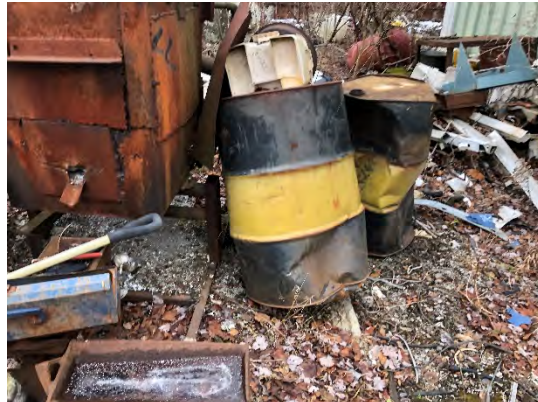
Photograph 52: Empty drums and homemade smelter.

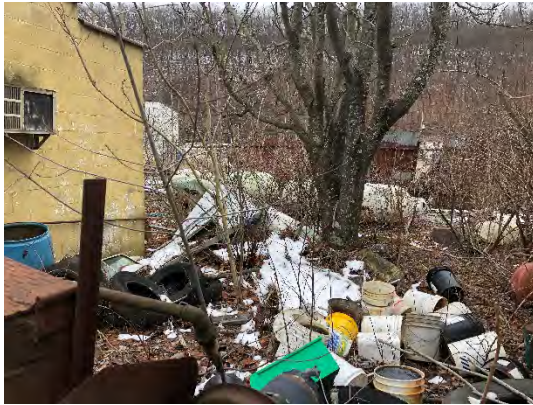
Photograph 53: Scrap and buckets between Dahlstrom office and Dahlstrom garage.

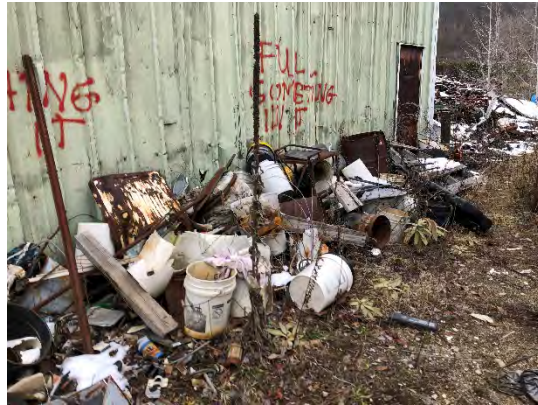
Photograph 54: Scrap alongside of Dahlstrom garage.

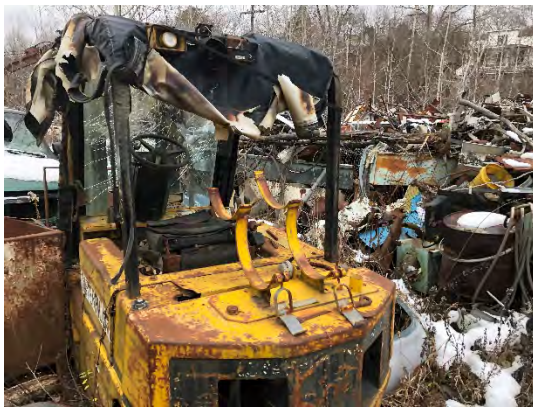
Photograph 55: Old equipment, scrap, drums.

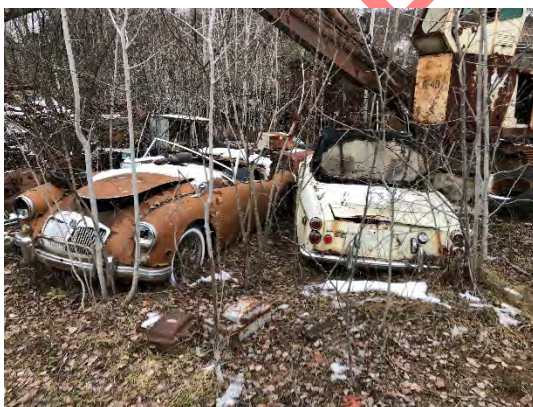
Photograph 57: Old cars and scrap yard equipment.

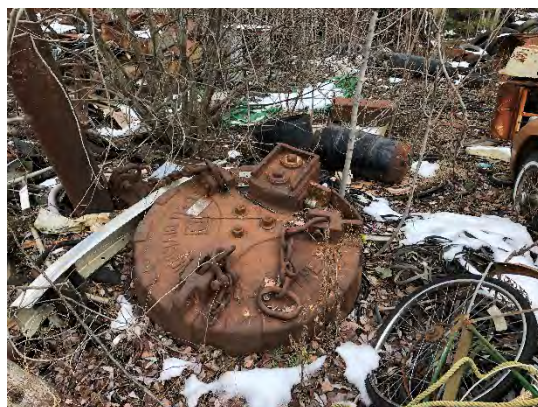
Photograph 58: Scrap yard equipment.

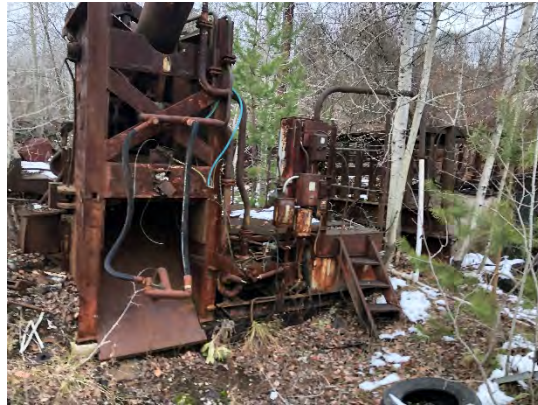
Photograph 60: Scrap yard equipment.

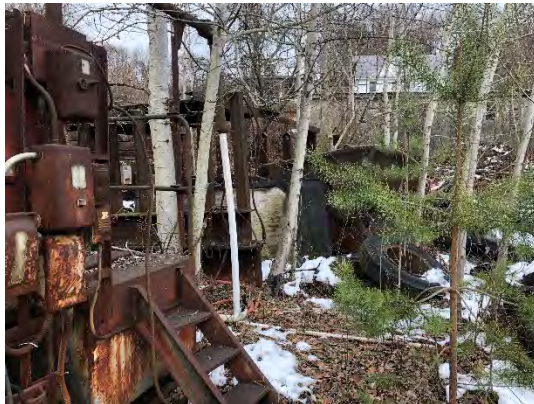
Photograph 61: Scrap yard equipment.

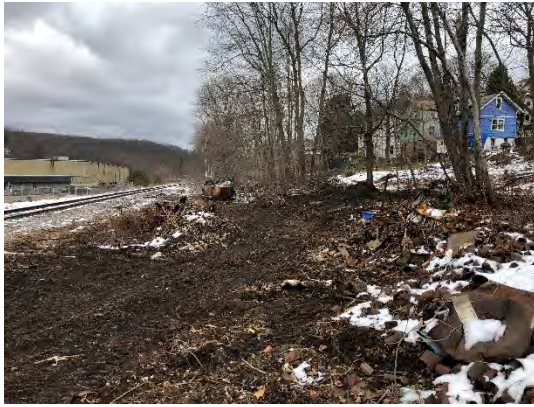
Photograph 69: Scrap piles and disturbed earth along northern boundary of subject site.

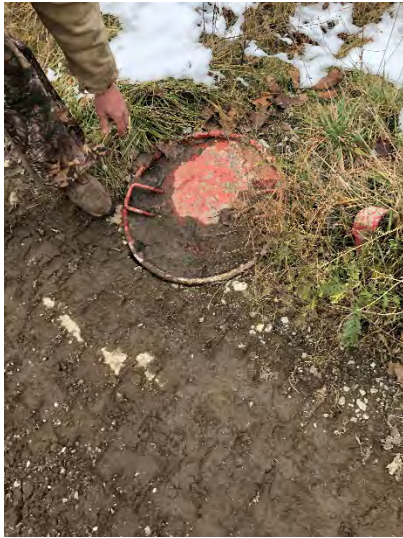
Photograph 71: Lid to water valve for public water supply.

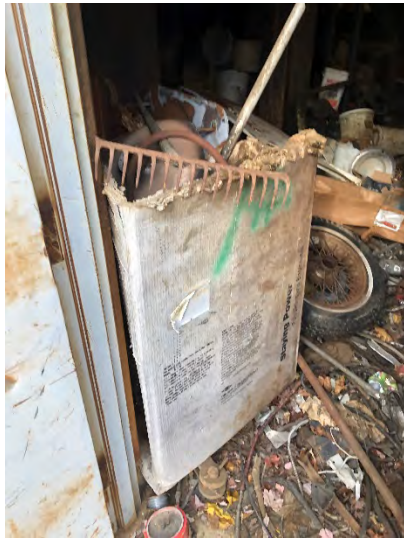
Photograph 85: Entrance to Dahlstrom garage.

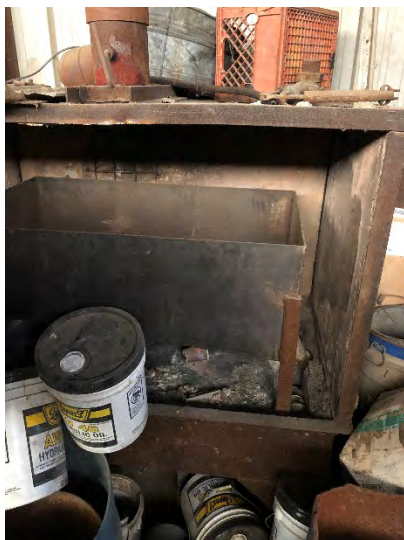
Photograph 91: Homemade smelter in Dahlstrom garage.

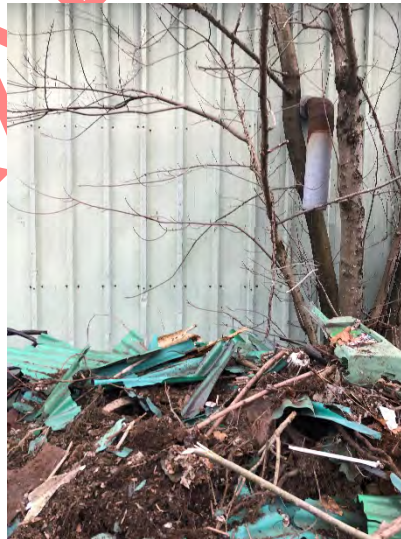
Photograph 96: Exhaust pipe on rear of Dahlstrom garage from homemade smelter.

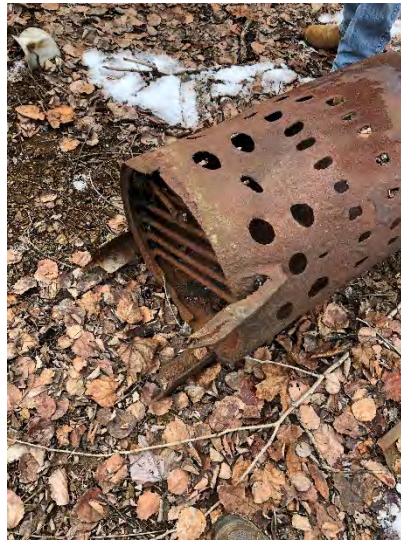
Photograph 98: Homemade smelter.

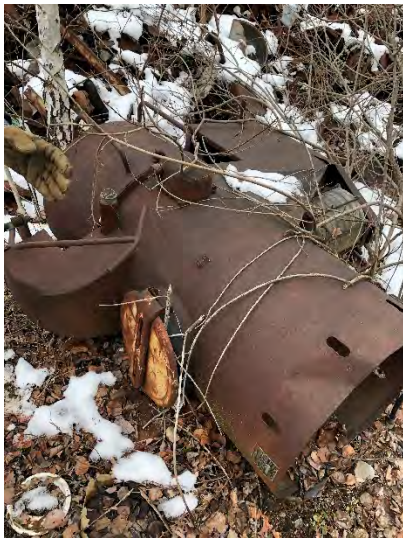
Photograph 99: Scrap in yard.
